# **SITE RE-ASSESSMENT / PRE- CERCLIS SITE SCREENING / DESK TOP REVIEW REPORTS**

Former St. Louis Lead and Zinc Smelters and  
Processing Sites  
St. Louis, Missouri

August 31, 2006

Missouri Department of Natural Resources  
Division of Environmental Quality  
Hazardous Waste Program

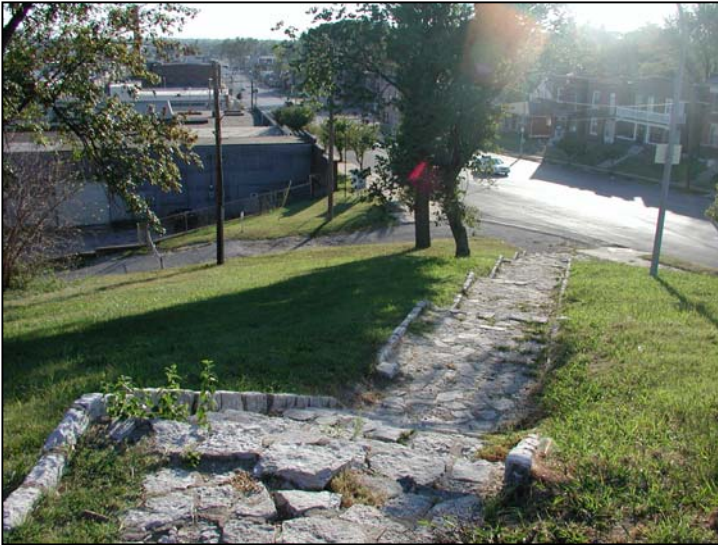
**Photograph 13**

Glendale Zinc Works Site,  
St. Louis, Missouri. Photo taken on  
November 19, 2004 by Michael D.  
Giovanini, DEQ, HWP, Superfund.

View of Bellerive Park, Sample  
Location 4, View looking southwest  
from parking lot.

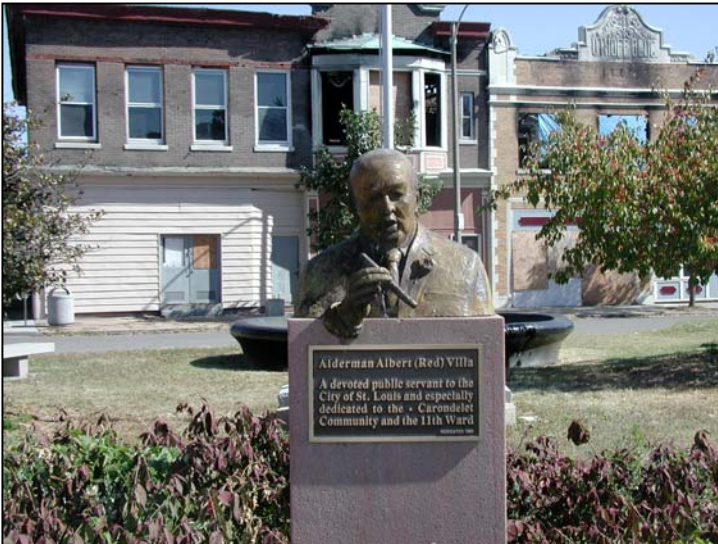
**Photograph 14**

Glendale Zinc Works Site,  
St. Louis, Missouri. Photo taken on  
October 5, 2004 by Michael D.  
Giovanini, DEQ, HWP, Superfund

View of Alderman Albert (Red) Villa  
Memorial Park, Sample location 5, Ivory  
Ave. and Schirmer St. View looking  
northeast.

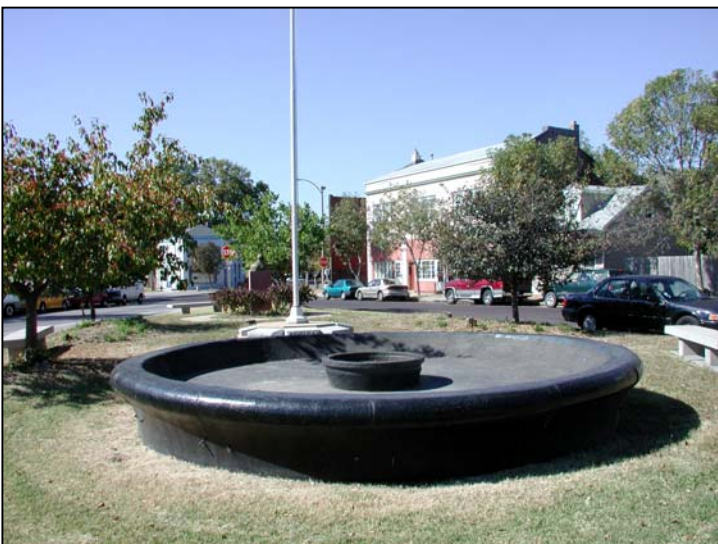
**Photograph 15**

Glendale Zinc Works Site,  
St. Louis, Missouri. Photo taken on  
October 5, 2004 by Michael D.  
Giovanini, DEQ, HWP, Superfund.

View of Alderman Albert (Red) Villa  
Memorial Park, Sample Location 5,  
From Steins St. View looking  
southwest.

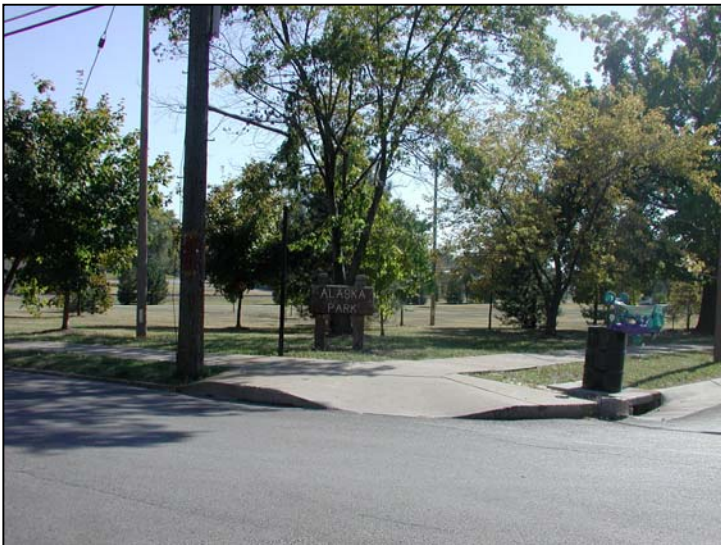
**Photograph 16**

Glendale Zinc Works Site,  
St. Louis, Missouri. Photo taken on  
October 5, 2004 by Michael D.  
Giovanini, DEQ, HWP, Superfund

View of Alaska Park, Sample location 6,  
Alaska and Koein Streets. View looking  
south.

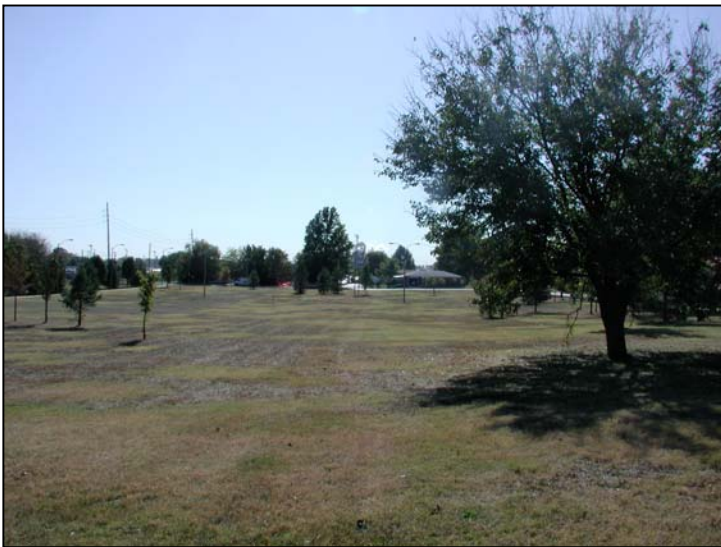
**Photograph 17**

Glendale Zinc Works Site,  
St. Louis, Missouri. Photo taken on  
October 5, 2004 by Michael D.  
Giovanini, DEQ, HWP, Superfund.

View of Alaska Park, Sample Location 6,  
From Koein Street. View looking  
southwest.

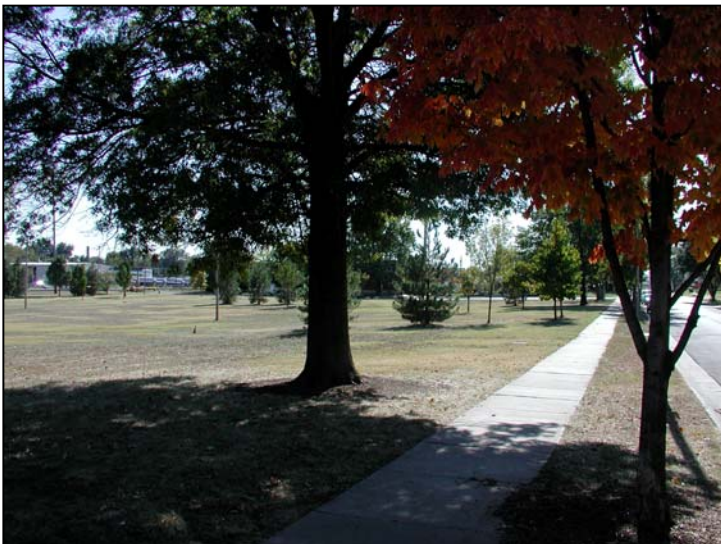
**Photograph 18**

Glendale Zinc Works Site,  
St. Louis, Missouri. Photo taken on  
October 5, 2004 by Michael D.  
Giovanini, DEQ, HWP, Superfund

View of Alaska Park, Sample Location  
6. View looking south from north end of  
park.

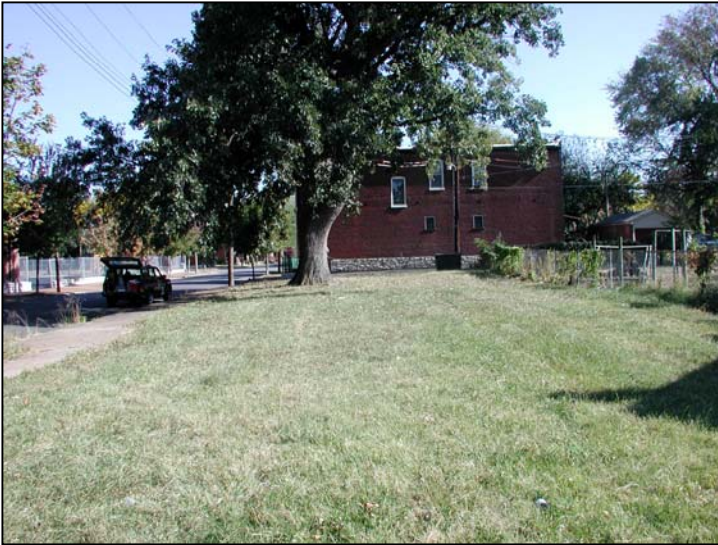
**Photograph 19**

Glendale Zinc Works Site,  
St. Louis, Missouri. Photo taken on  
November 22, 2004 by Michael D.  
Giovannini, DEQ, HWP, Superfund

View of 7700 Michigan, Sample  
Location 7. View looking south from  
Michigan and Schirmer.

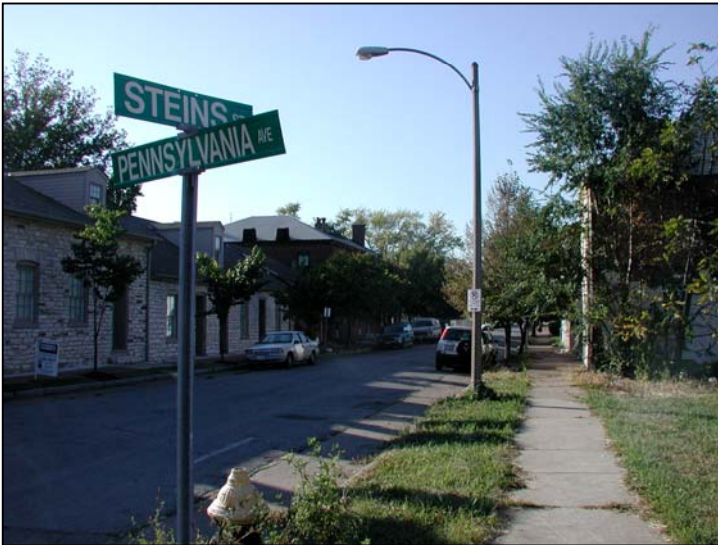
**Photograph 20**

Glendale Zinc Works Site,  
St. Louis, Missouri. Photo taken on  
November 22, 2004 by Michael D.  
Giovannini, DEQ, HWP, Superfund

View of 201 Steins, Sample location 8,  
Steins and Pennsylvania Ave.

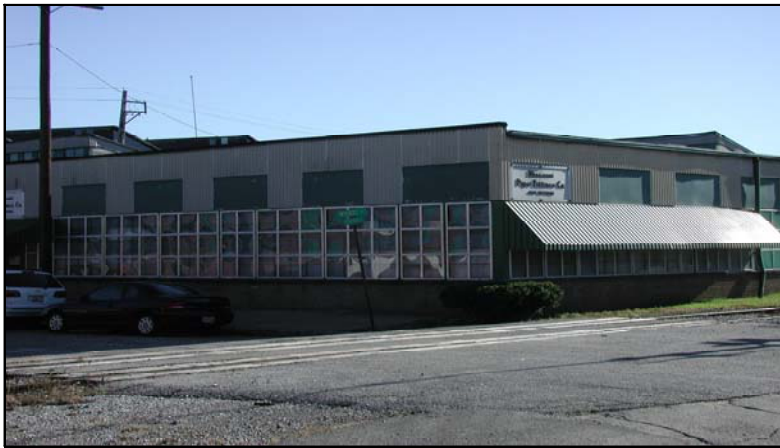
**Photograph 1**

M. Holtzman Metal Co. Site,  
St. Louis, Missouri. Photo taken on  
November 19, 2003 by Michael D.  
Giovanini, DEQ, HWP, Superfund

View of smelter location on McKissock  
Street, presently the Missouri Pipe  
Fitting Company building. View  
looking east.

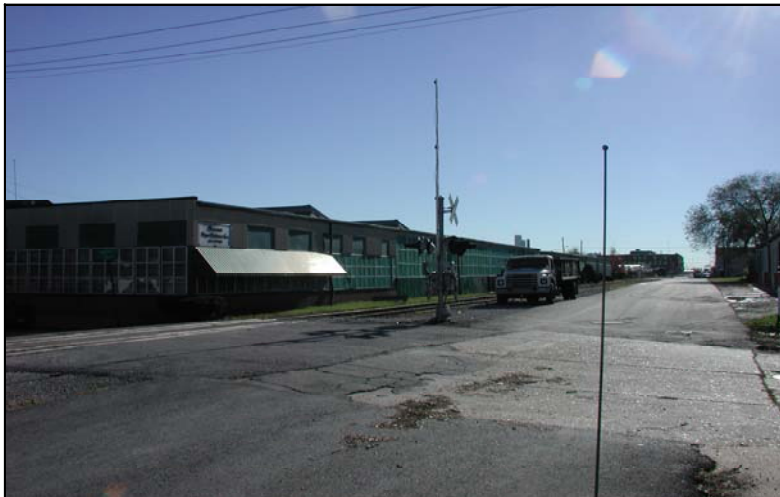
**Photograph 2**

M. Holtzman Metal Co. Site,  
St. Louis, Missouri. Photo taken on  
November 19, 2003 by Michael D.  
Giovanini, DEQ, HWP, Superfund

View of smelter location on McKissock  
Street, presently the Missouri Pipe  
Fitting Company building located off of  
Withers Street. View looking east.

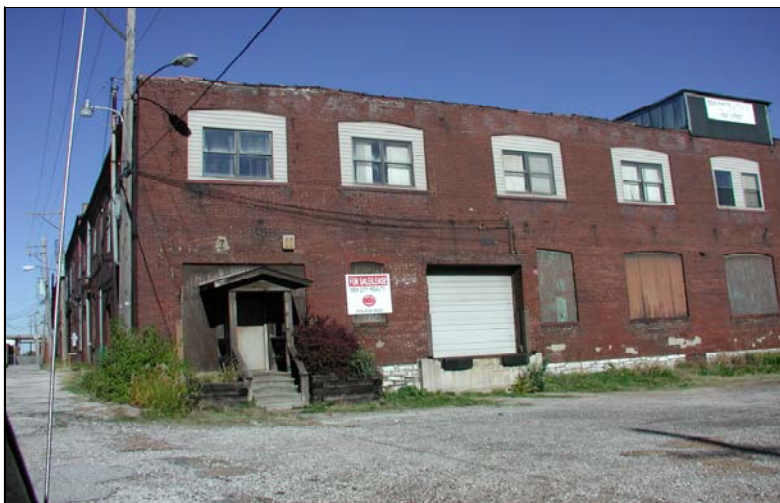
**Photograph 3**

M. Holtzman Metal Co. Site,  
St. Louis, Missouri. Photo taken on  
November 19, 2003 by Michael D.  
Giovanini, DEQ, HWP, Superfund

View of Trio Paper and Box Company  
building located on the smelter block,  
McKissock Street. View looking west.

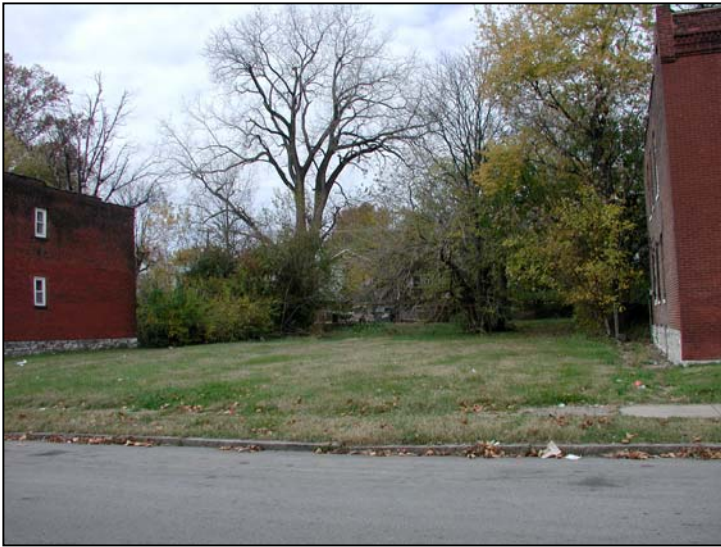
**Photograph 15**

1902 - 1906 Desoto St., Sample location  
8. View looking southeast.

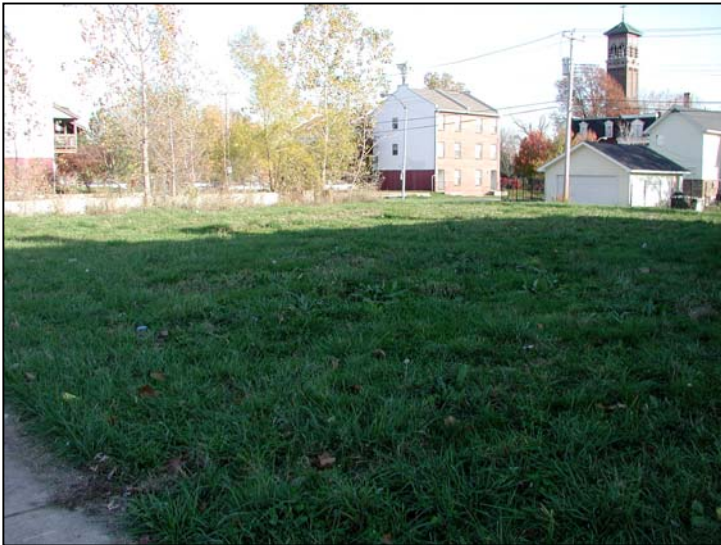
**Photograph 16**

1907 -1911 Desoto St., Sample location  
9. View looking north from Desoto St.

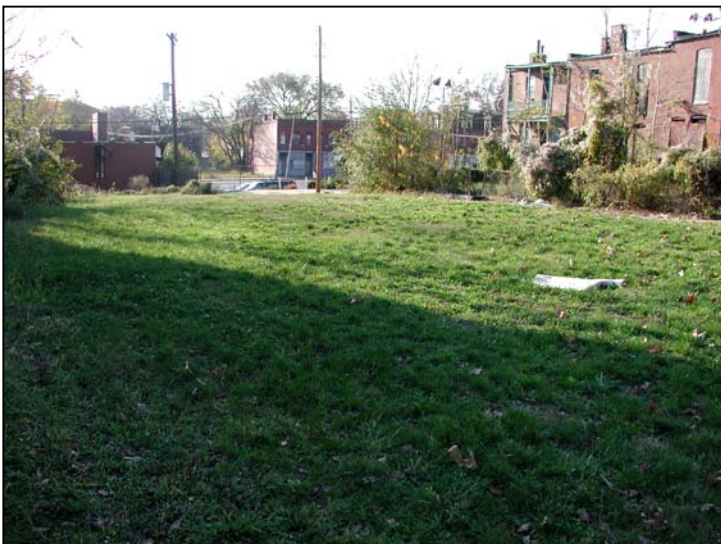
**Photograph 17**

2100 - 2110 John Ave., Sample location  
10. View looking east from John Ave.

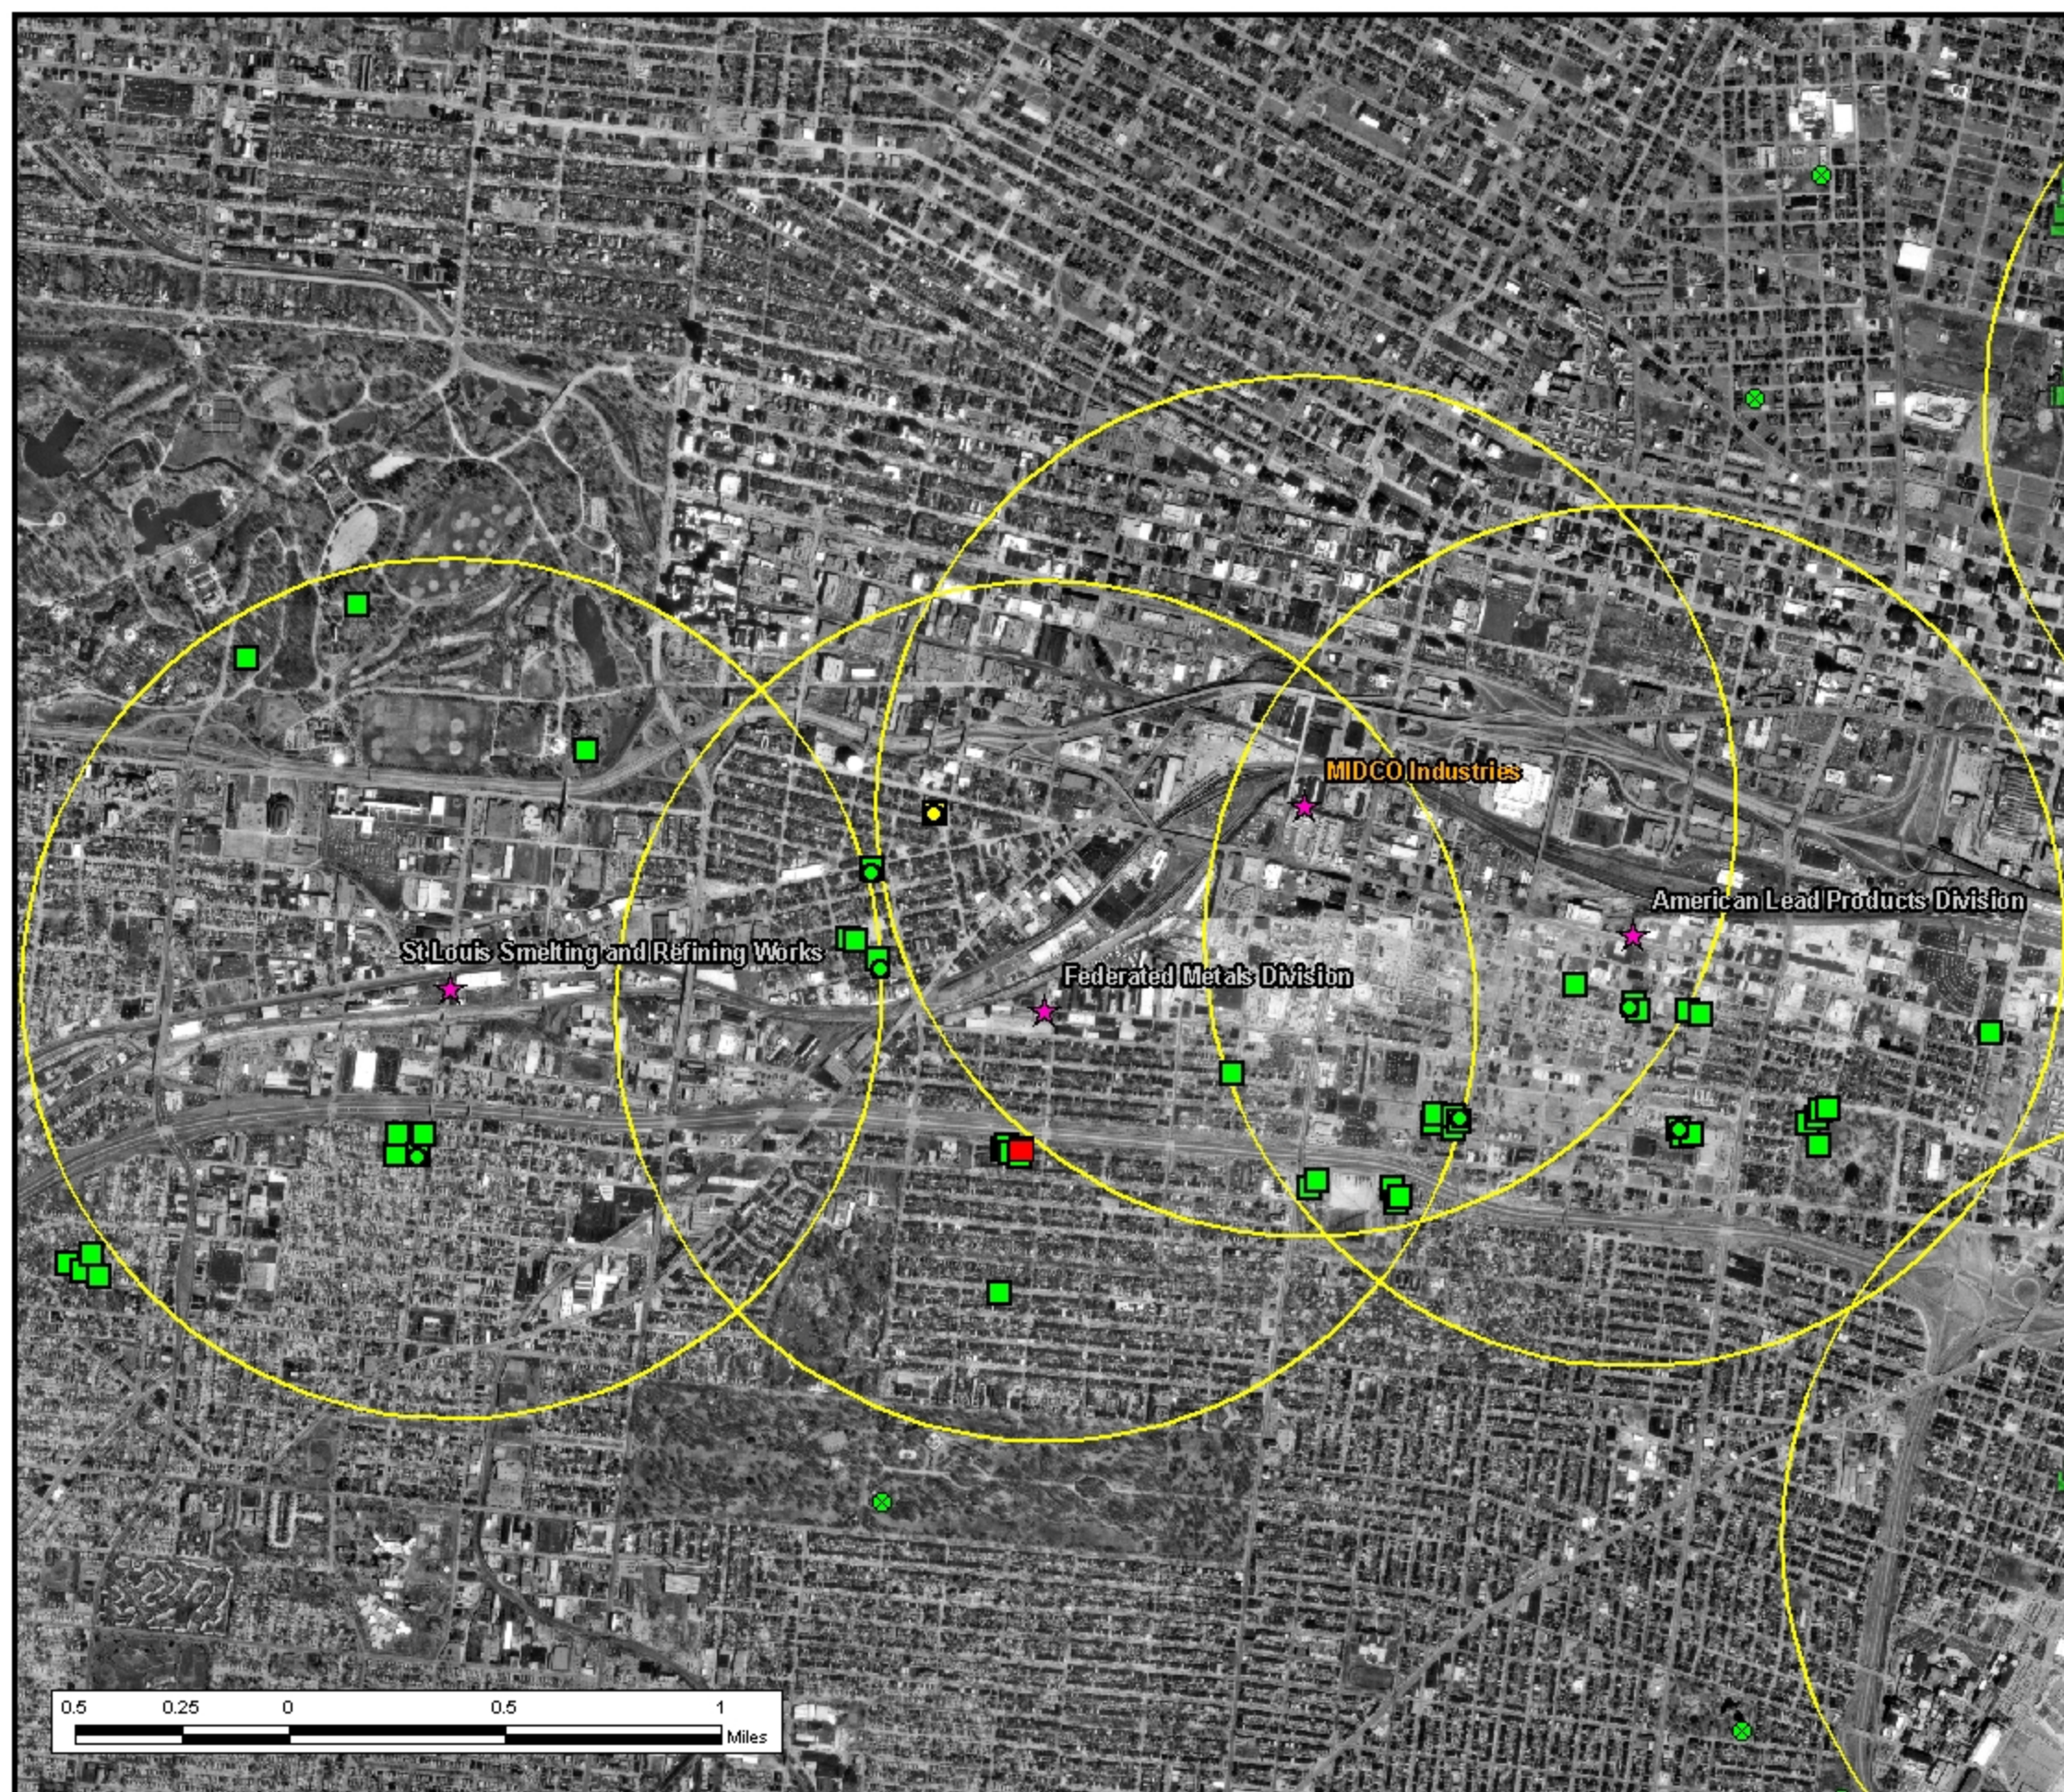
American Lead Products Co., Federated Metals Division,  
MIDCO Industries and St. Louis Smelting & Refining Works  
St. Louis City, MO

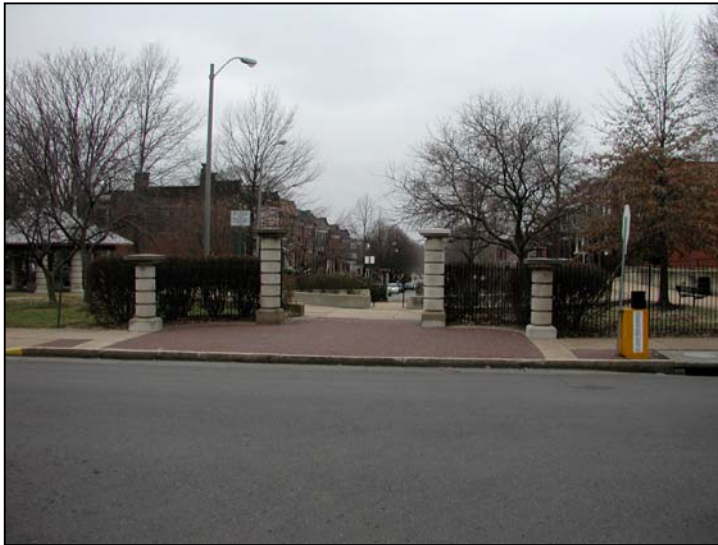
**Photograph 1**

Dundee Place Park, view of sampling  
location 1. View is facing west from Spring  
Avenue.

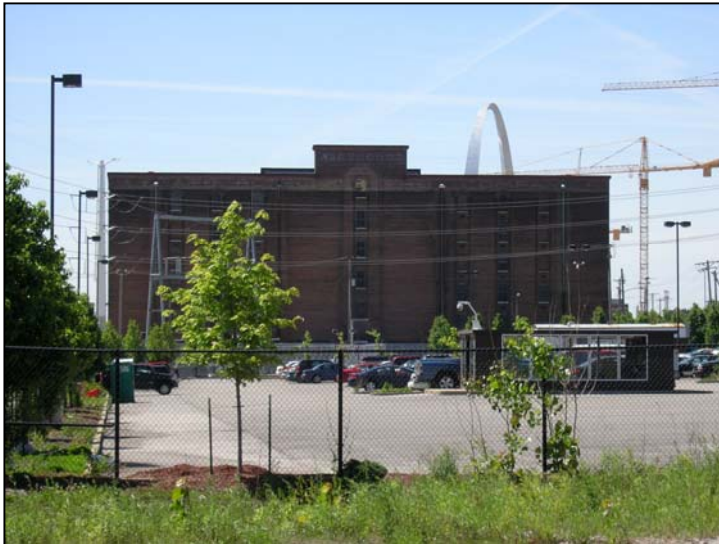
**Photograph 1**

The former St. Louis Lead & Oil Works  
site location. View from Cass St. south  
towards a paved parking lot.

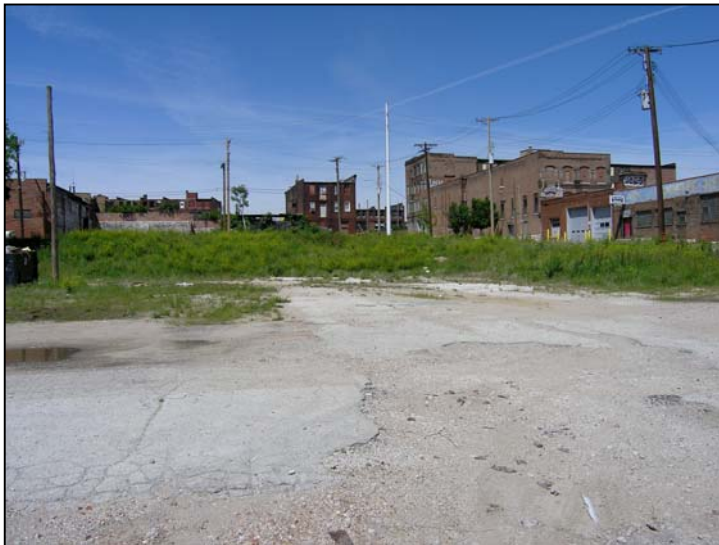
**Photograph 2**

The former St. Louis Lead & Oil Works  
site location. View from Cass St. And  
1st St. west towards a paved/gravel  
parking lot.

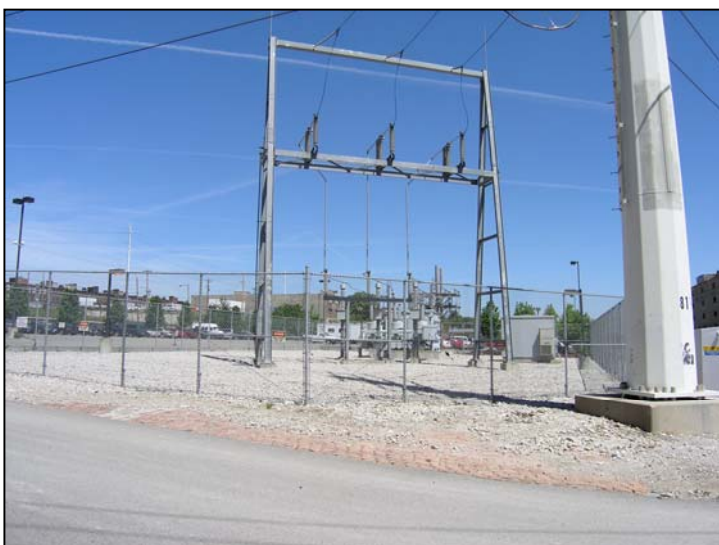
**Photograph 3**

The former St. Louis Lead & Oil Works  
site location. View from O'Fallon St.  
and 1st St. north towards a electrical  
substation.

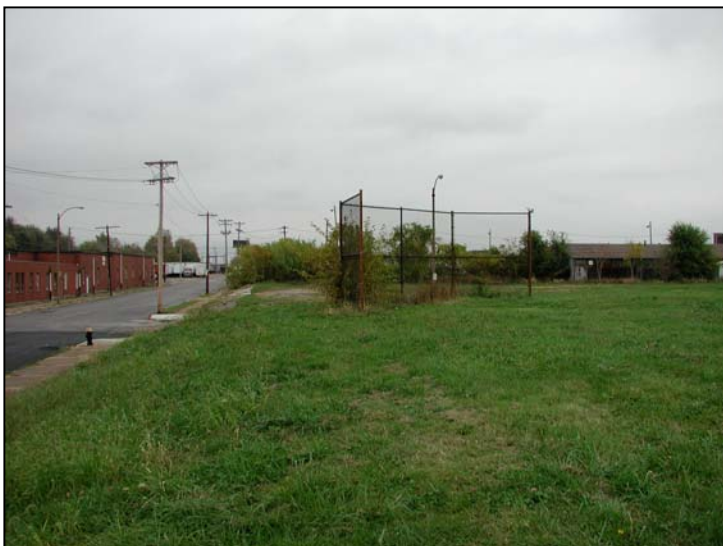
**Photograph 4**

Mullanphy Park, Sample Location 1.  
View looking north along 11th St.  
towards ball field.

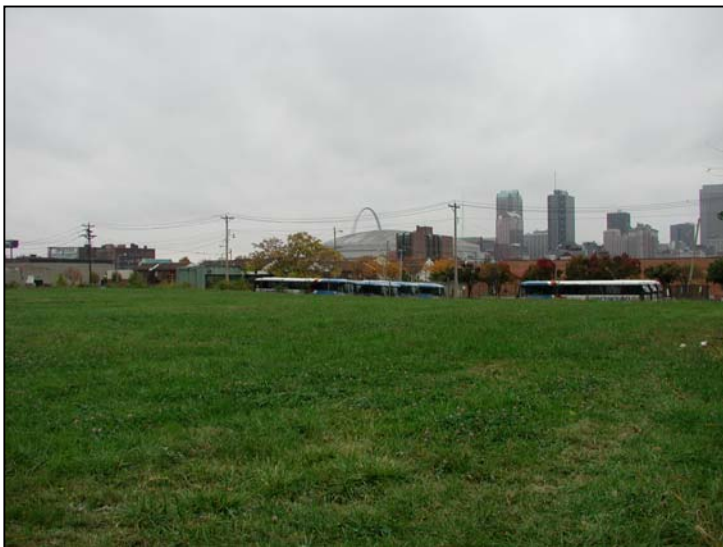
**Photograph 5**

Mullanphy Park, Sample Location 1.  
View looking south along 11th St.  
towards ball field.

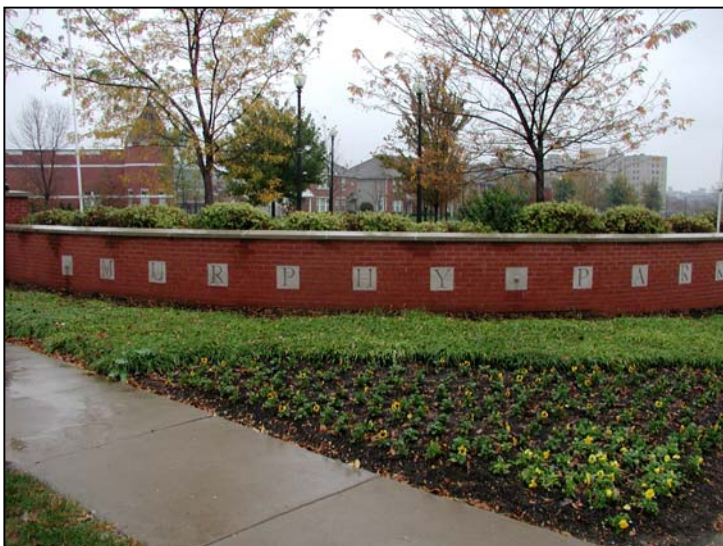
**Photograph 6**

Murphy Park, Sample Location 2. View  
looking east towards front entrance.

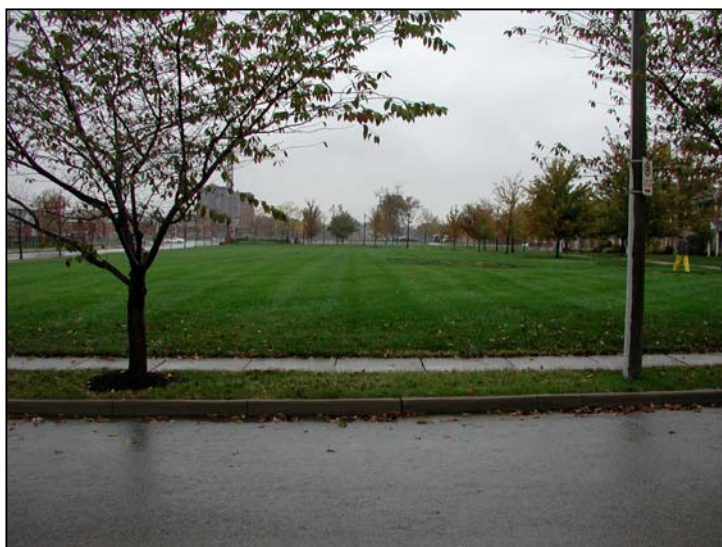
**Photograph 7**

Murphy Park, Sample Location 2. View  
looking north.

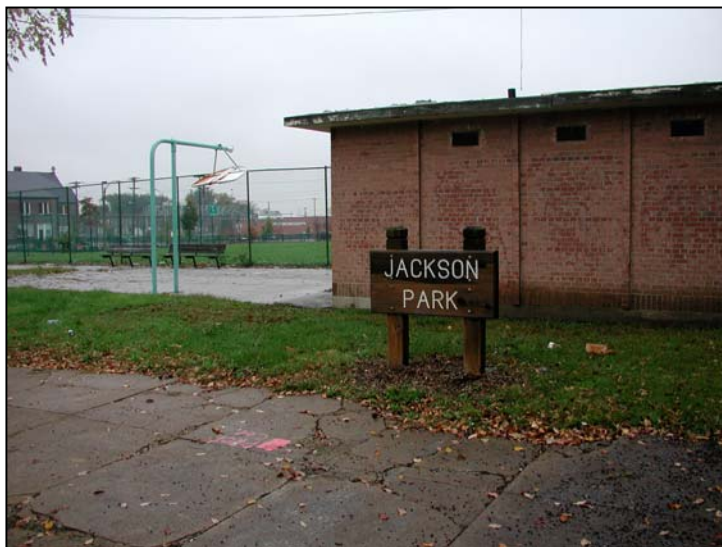
**Photograph 8**

Jackson Park, Sample Location 3. View  
looking northeast from North Market St.

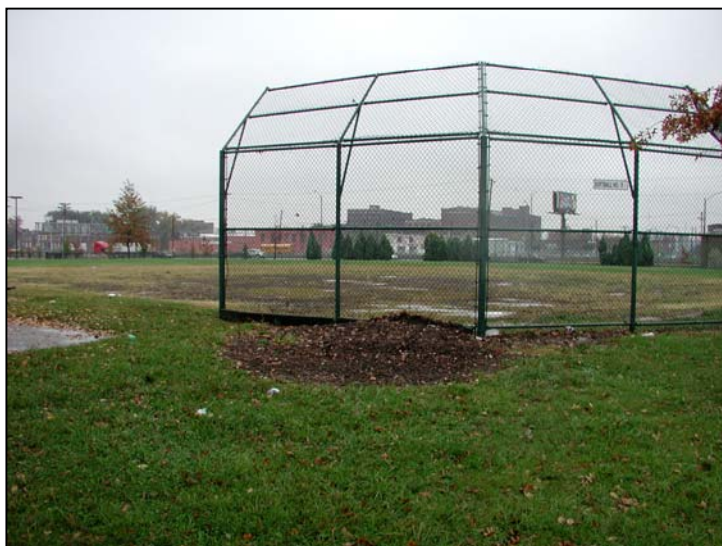
**Photograph 9**

Jackson Park, Sample Location 3. View  
looking northeast towards ballfield.

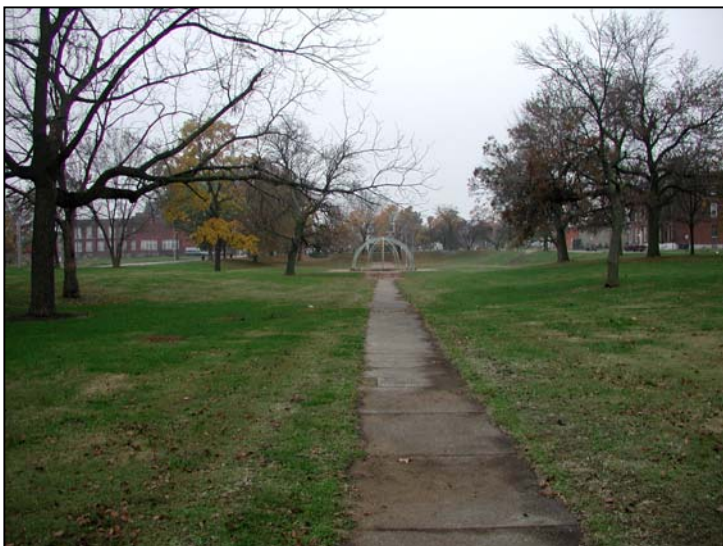
**Photograph 10**

St. Louis Place Park, Sample Location 4.  
View looking south from north end of  
the park near St. Louis St.

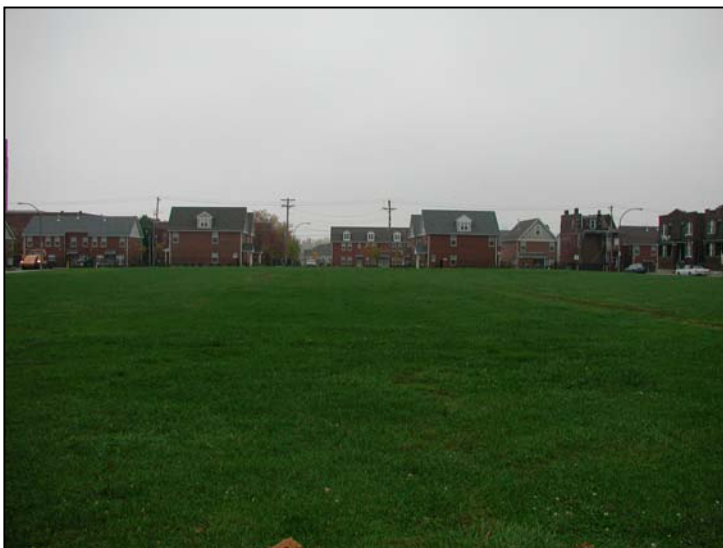
**Photograph 11**

St. Louis Place Park, Sample Location 4.  
View looking south from North Market  
St.

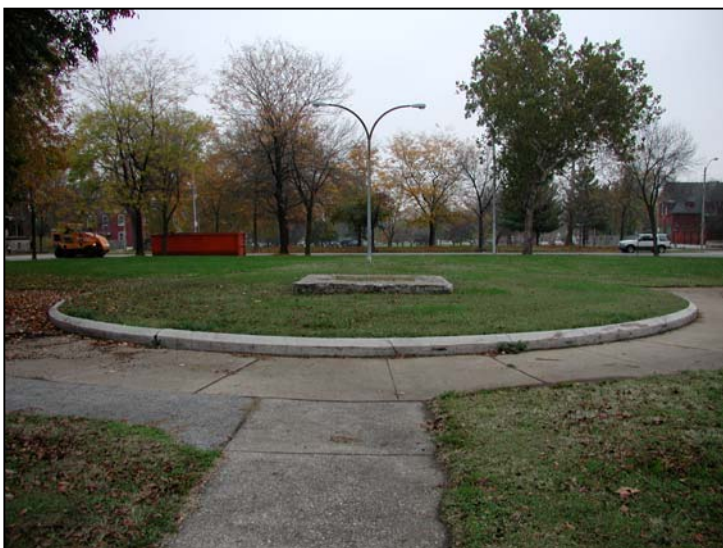
**Photograph 12**

St. Louis Place Park, Sample Location 4.  
View looking north towards St. Louis St.

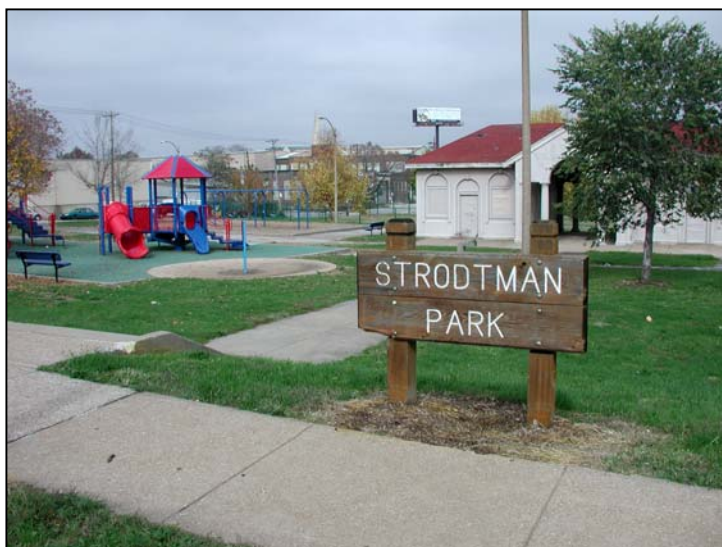
**Photograph 13**

Strodtman Park, Sample Location 5.  
View looking north from Palm St.

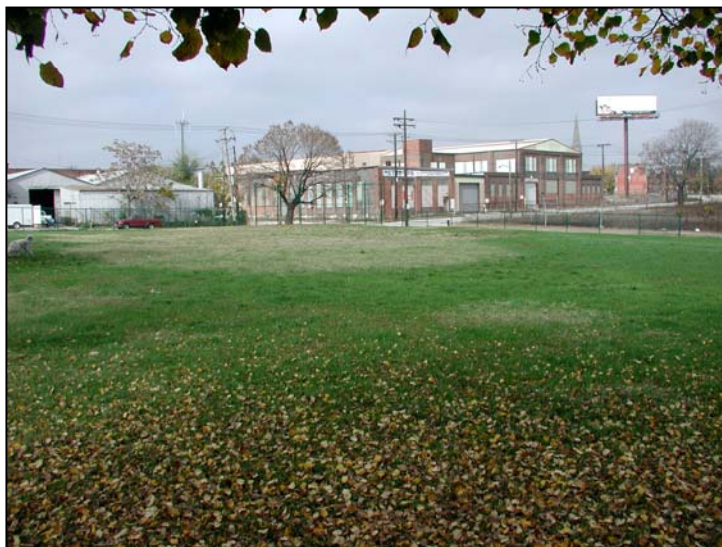
**Photograph 14**

Strodtman Park, Sample Location 5.  
View looking northwest towards ball  
field.

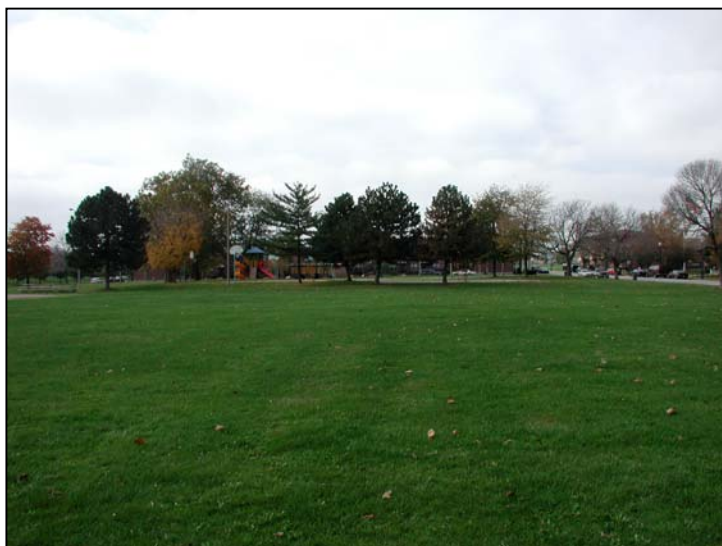
**Photograph 15**

Loretta Hall Park, Sample Location 6.  
View looking west from 14th St.

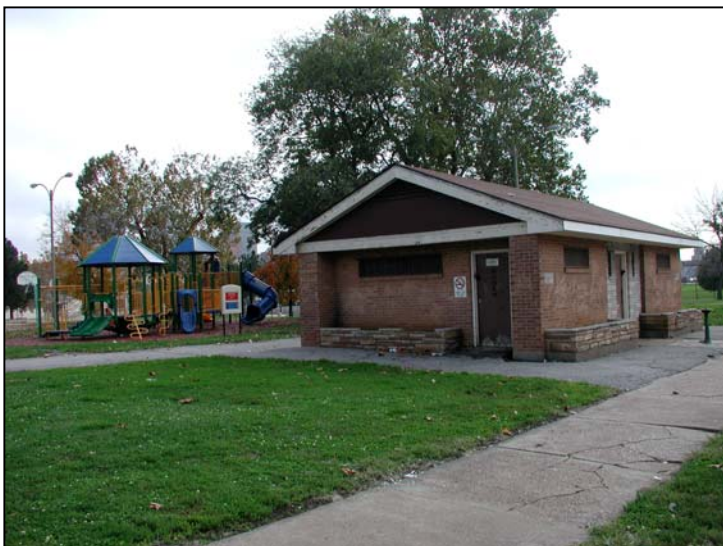
**Photograph 16**

Loretta Hall Park, Sample Location 6.  
View looking south along Selby St.

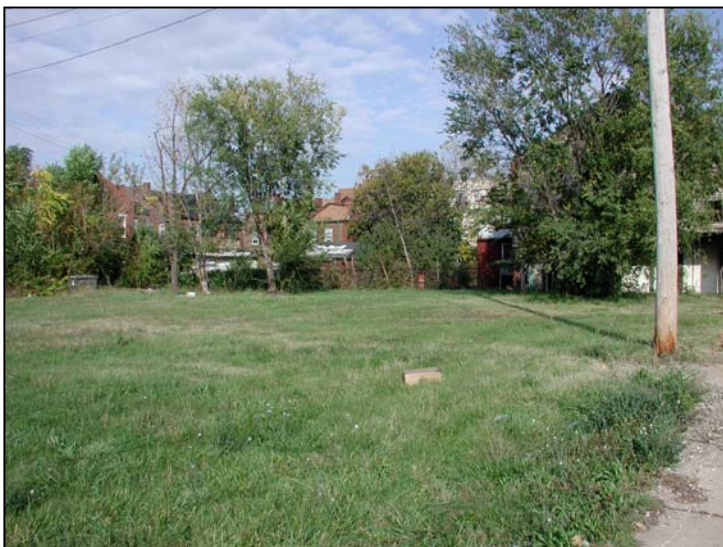
**Photograph 17**

1313 & 1314 Benton St., Sample  
Location 7. View looking north from  
Benton and 14th St.

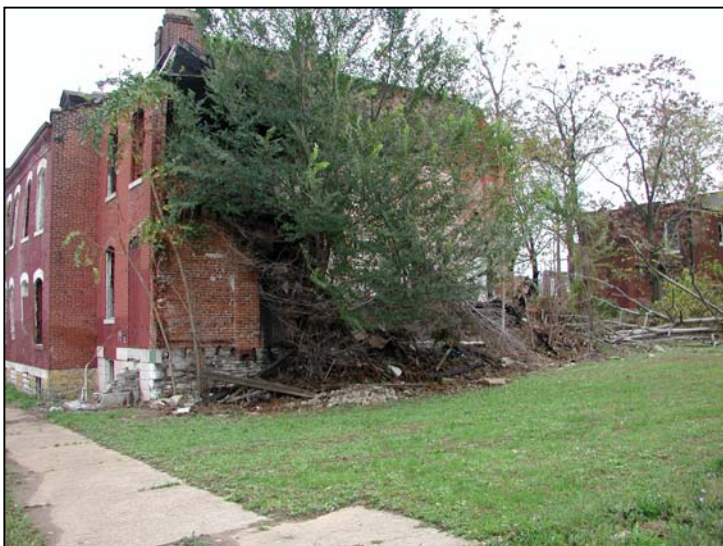
**Photograph 18**

1904 Montgomery St., Sample Location  
8. View looking south from  
Montgomery and 14th St.

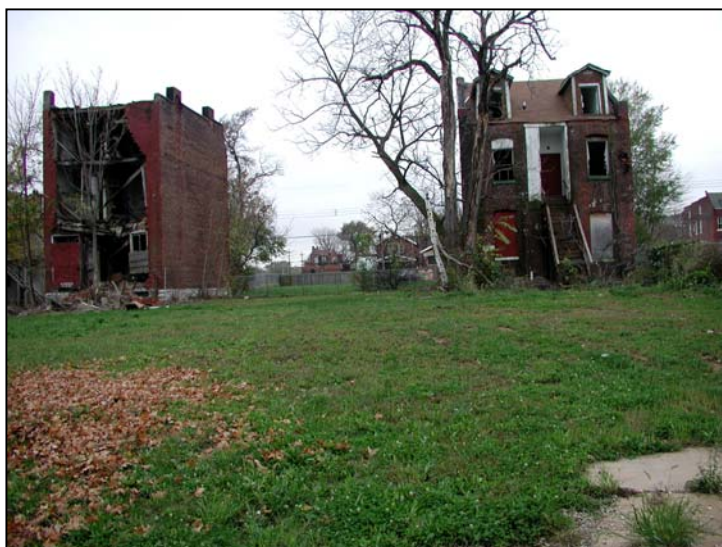
**Photograph 19**

1920 Montgomery St., Sample Location  
9. View looking south from  
Montgomery St.

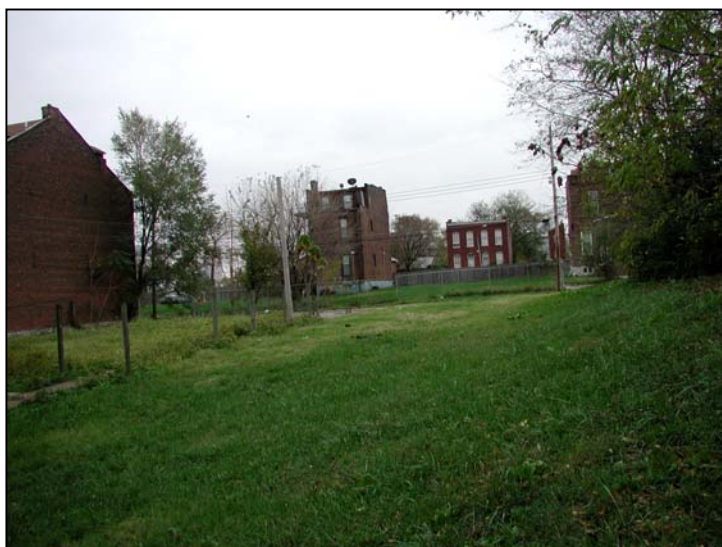
**Photograph 20**

1922 Montgomery St., Sample Location  
10. View looking south from  
Montgomery St.

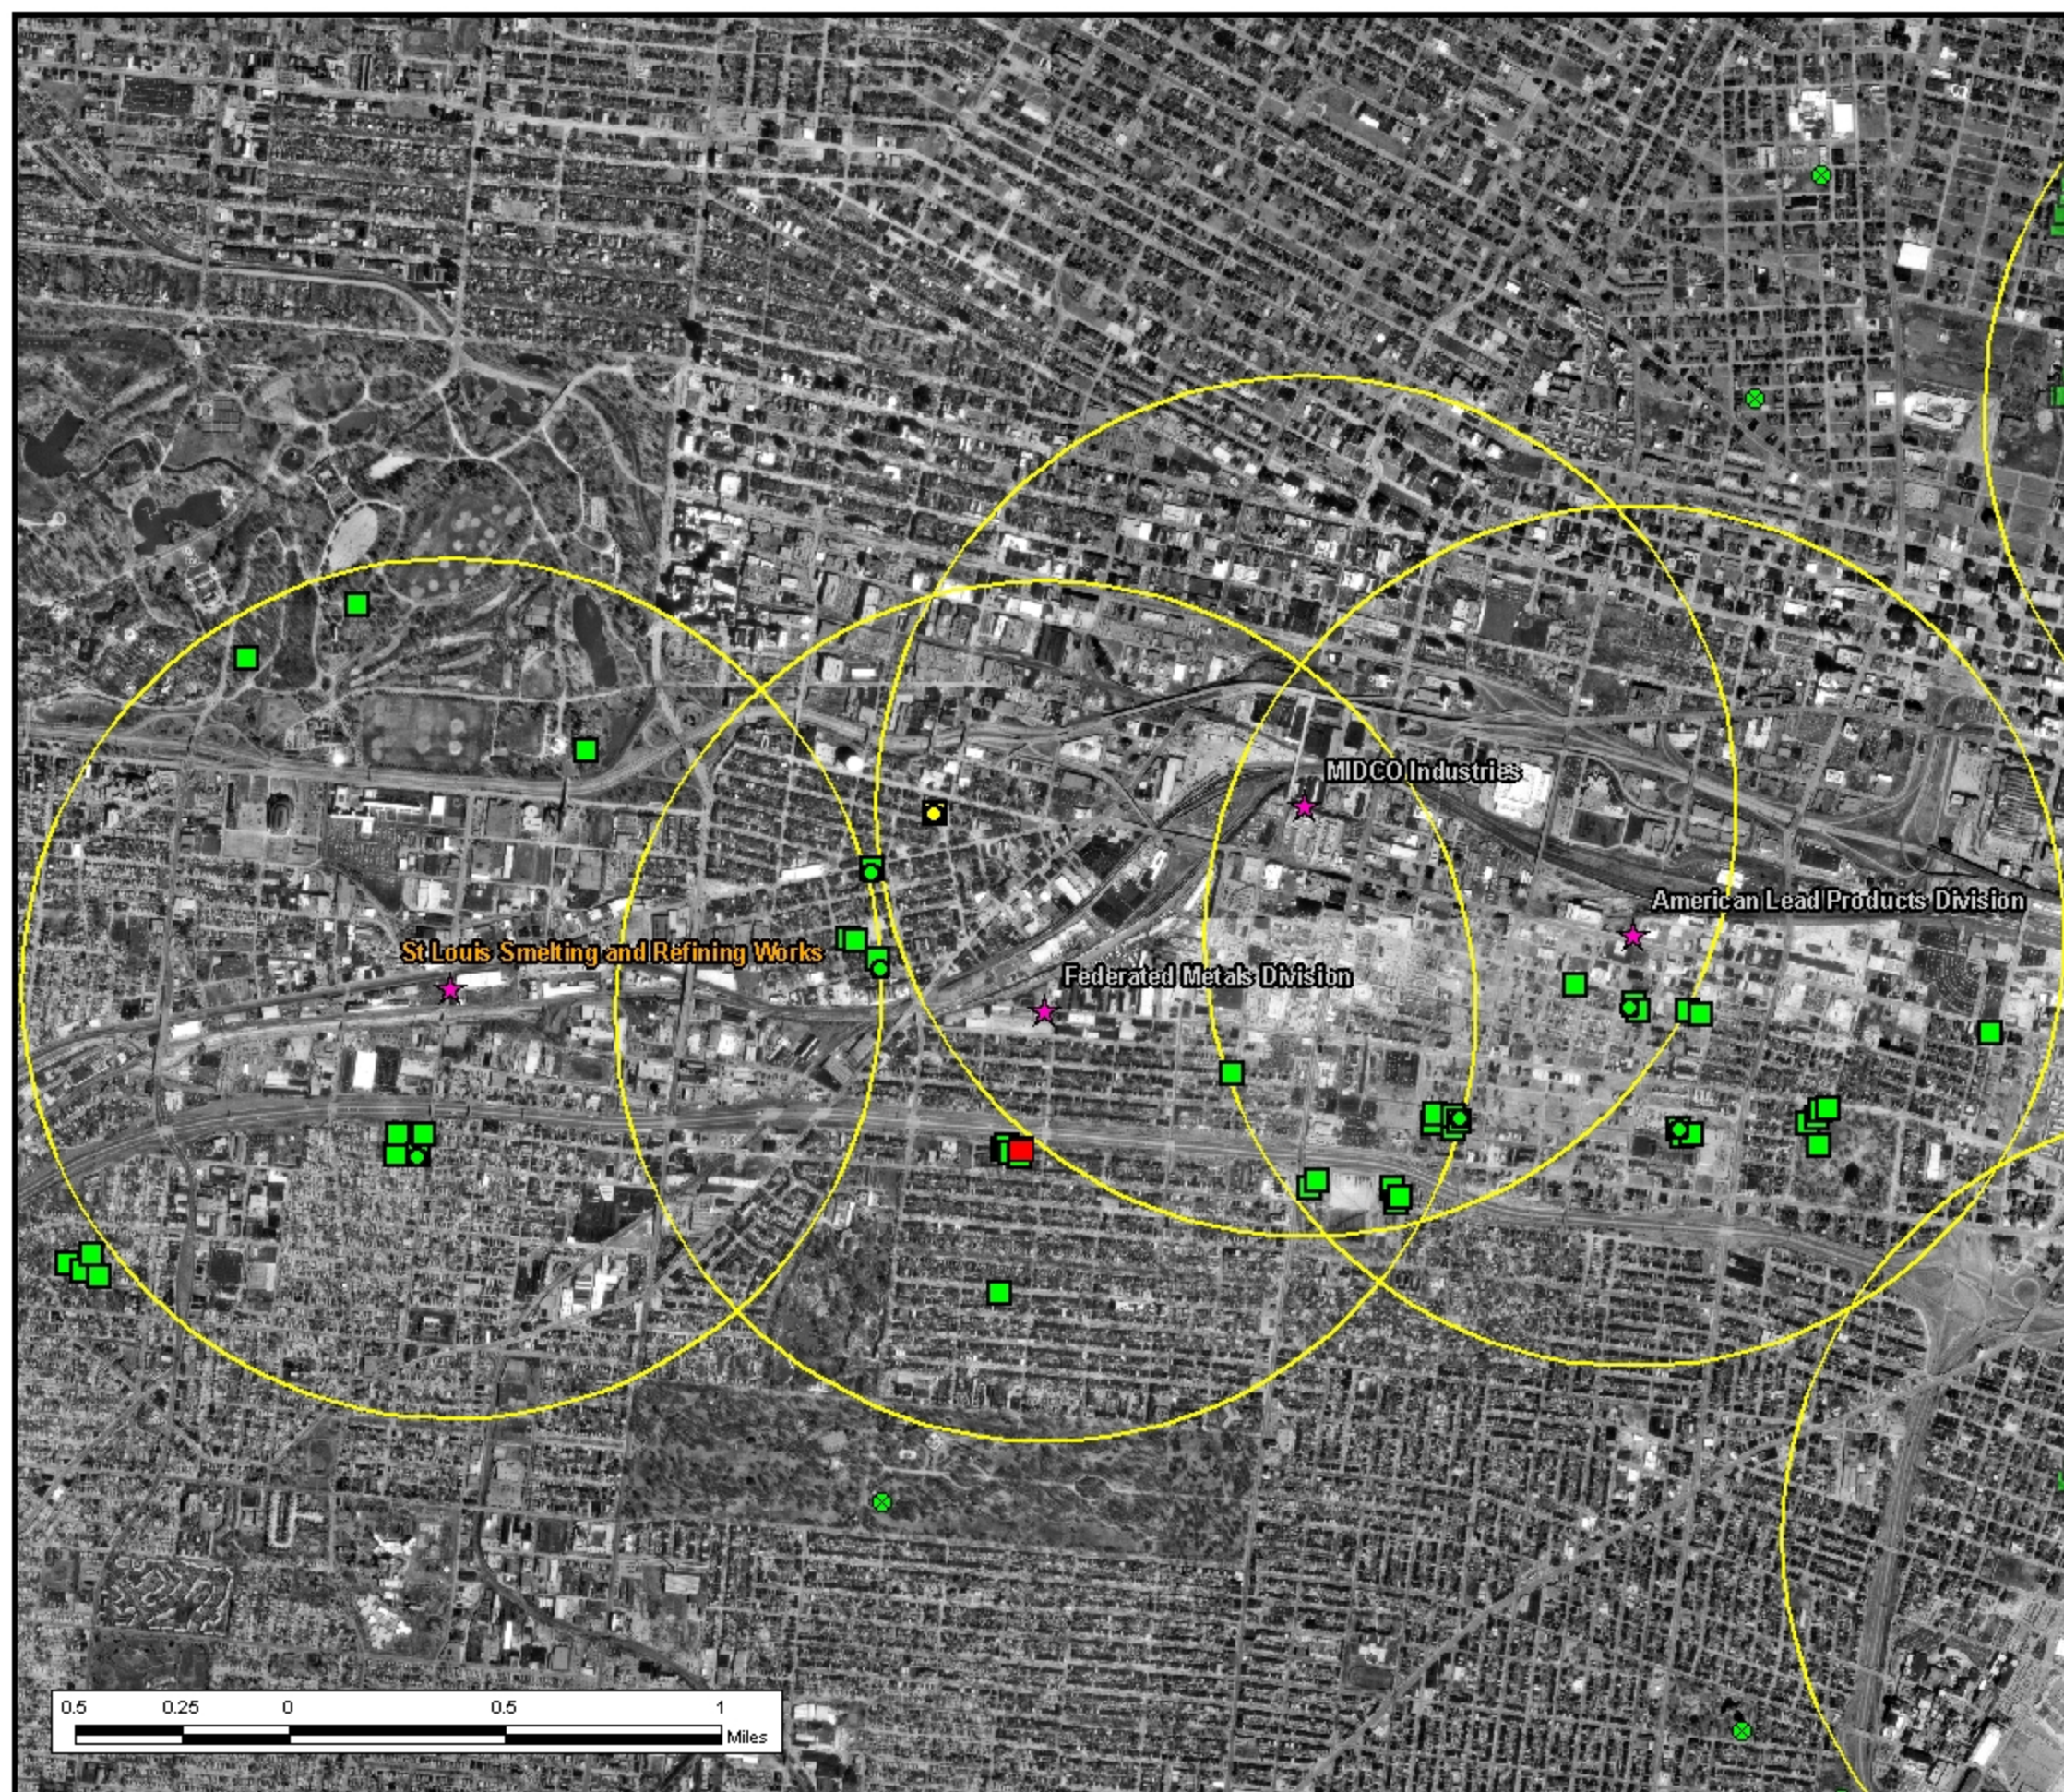
American Lead Products Co., Federated Metals Division,  
MIDCO Industries and St. Louis Smelting & Refining Works  
St. Louis City, MO

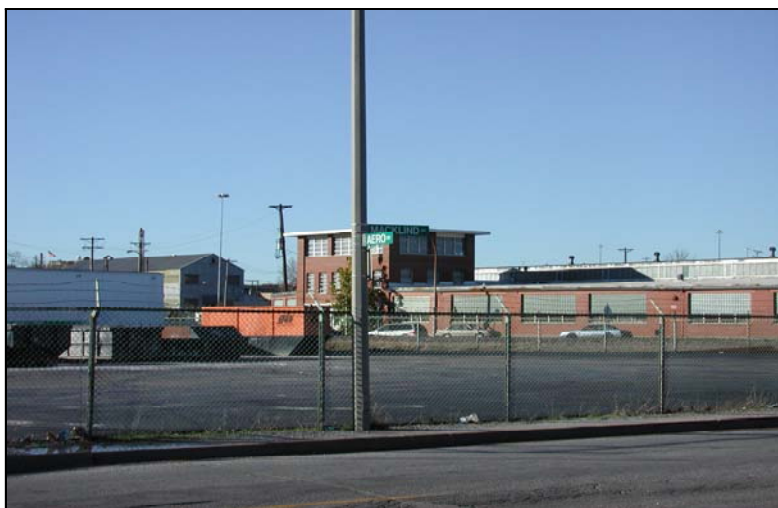
**Photograph 2**

View of Walsh & Associated building  
located in St. Louis Smelting & Refining  
Works area, Manchester & Macklind  
Streets. View looking northeast.
